# Manhole Inspection Summary

Manhole # S37EE1009MH

**Location** Address: **3802 JUNIPER RD**

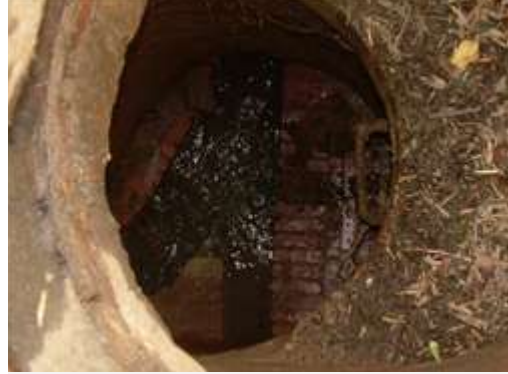
Top View

Corroded steps. Evidence of surcharge - Bench debris.

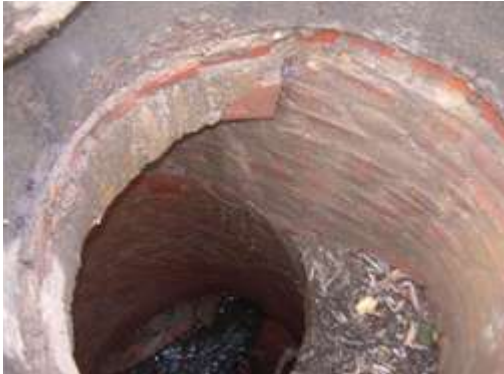
Defect

Frame leaks. Adjustment deterioration and infiltration. Corbel infiltration. Barrel root intrusion and infiltration.

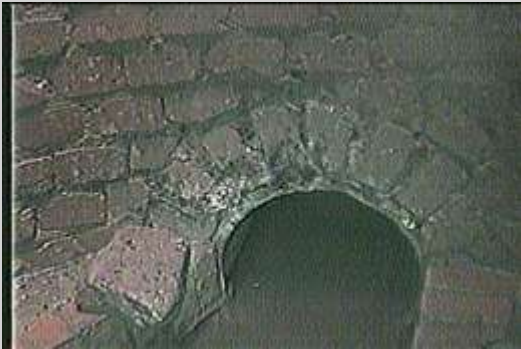
### 12 in. Circular Gravity Sewer Pipe Out @ 12 O'Clock

Barrel deterioration and infiltration.

Infiltration: **Evidence** Pipe Seal Cond: **Cracked**

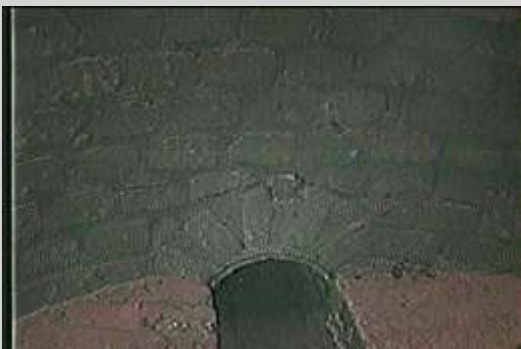
### 8 in. Circular Gravity Sewer Pipe In @ 6 O'Clock

Barrel deterioration and infiltration.

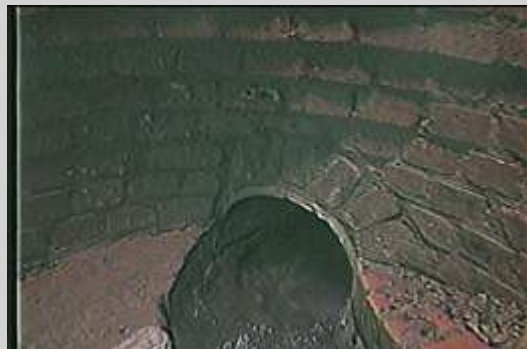
Pipe In @ 8 O'Clock

Barrel deterioration and infiltration.
